I-75 KENTON COUNTY SLIDE
KYHPR ⁴⁸⁵ 63-16, HPR-1(4), PART II

Herbert F. Southgate
⁴⁷⁰
Research Engineer

SUBJECT: Research Report (Interim);
"I 75, Kenton County Slide;" HPR-1(4),
Part II; KYHPR-63-16

I 75, KENTON COUNTY SLIDE
KYHPR 63-16, HPR-1(4), Part II

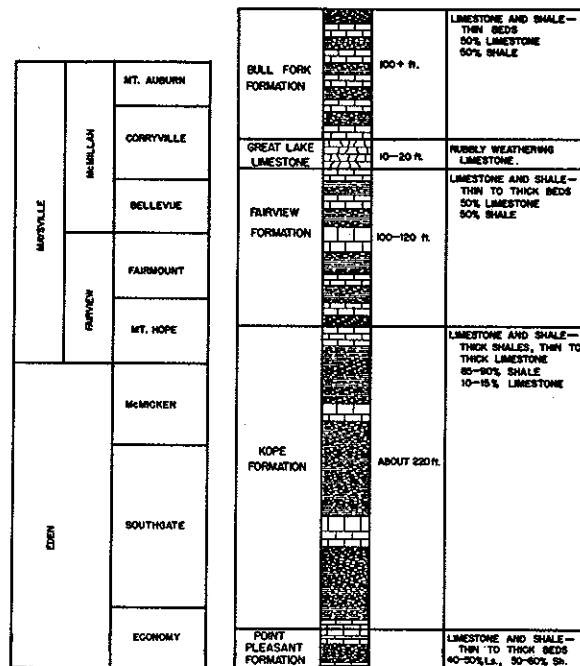
Figure 1. Generalized Columnar Section for the Covington, I 75 Slide Area.

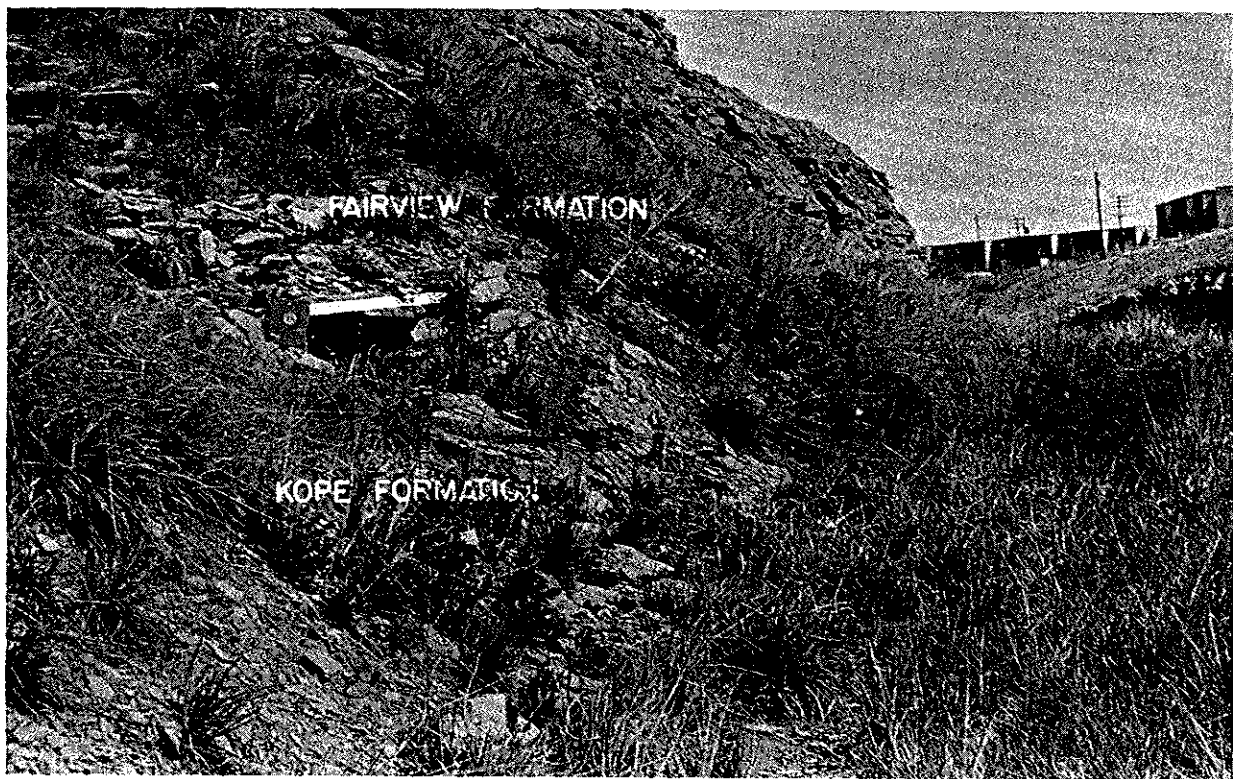
Figure 2. Fairview and Kope Formations at the Covington, I 75 Slide Area.

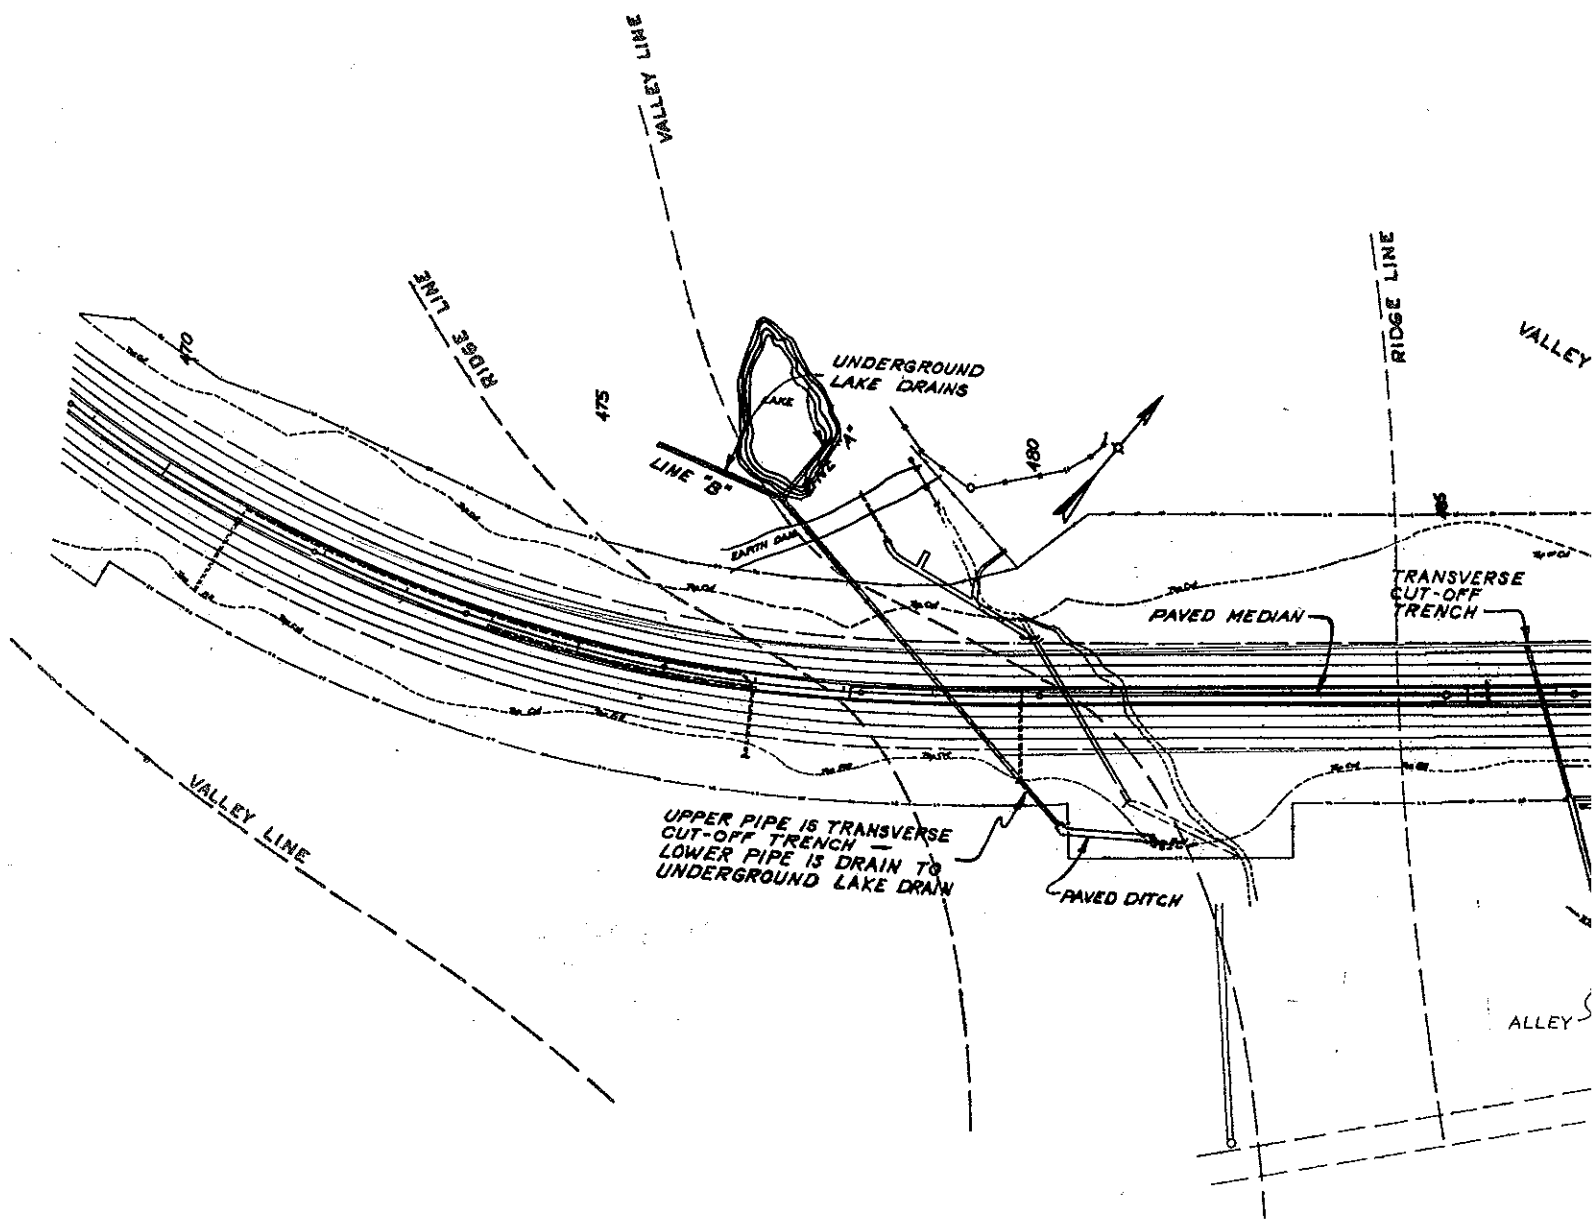
Figure 3. Plot Plan of Landsl

During the week of April 9, 1962, a significant amount of earth movement occurred near Station 487 and was sufficient to cause major damage to the essentially completed construction project. The site was visited by Division of Research personnel on April 16, 1962, and conditions were noted as shown in Figure 3. Figure 5, taken April 16, 1962, shows the extent of shoulder settlement. It was noted that the DGA base no longer supported the pavement, and the guardrail posts were out of alignment. There was a heavy clay embankment slope up to the shoulder pavement, thus preventing water from draining out of the DGA base.

During the summer of 1962 certain measures were undertaken to repair the damage and to prevent further movement. The measures are indicated by solid red lines in Figure 3 and are listed below:

1. In the major slide area, the embankment was removed to a depth of about 25 feet below the pavement. This zone was backfilled, recompacted, brought up to grade, and a new base and concrete pavement were constructed.
2. A perforated pipe was installed transversely at Station 487+05, about 12 feet below the pavement. The pipe extended to the median strip and was backfilled with sand.

The plans and specifications provided for the following corrective measures (see Figure 3):

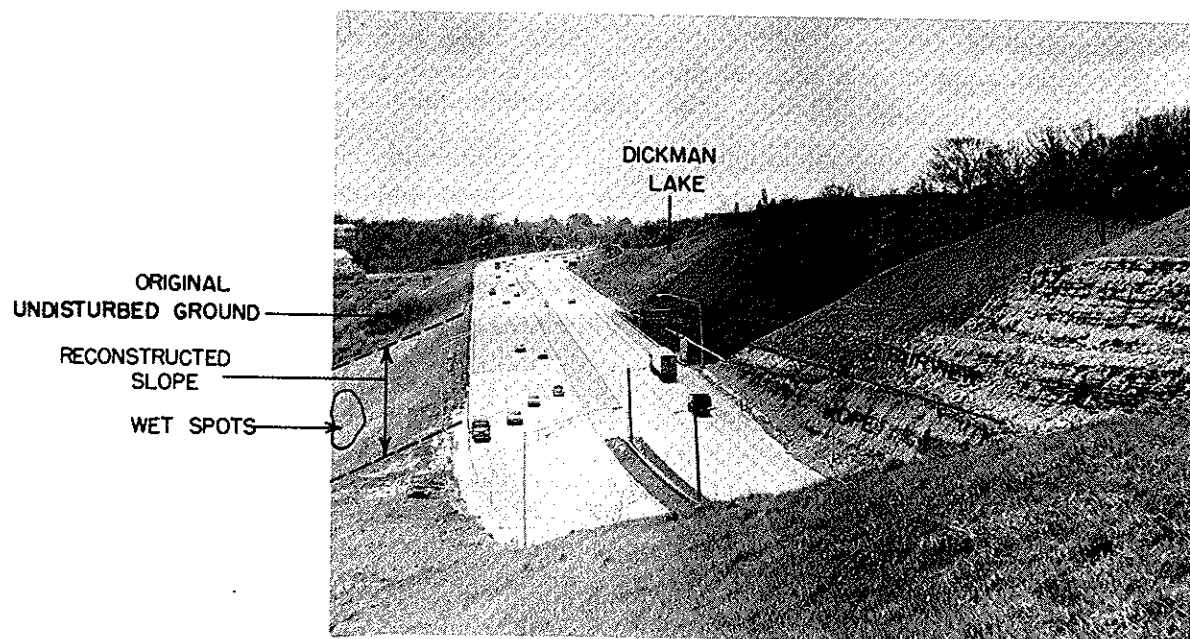
Dickman Lake (see Figures 3 and 4) had been created by damming the depression created by an old quarry. Subsequently, sediments formed in the lake bed that varied from 10 to 35 feet thick above the limestone and shale deposits. Quite naturally, these unconsolidated sediments contained a great amount of water. It was estimated that this water would require five years to drain at the rate of 50 gph.

Figure 4. Overall View (Looking South) of Slide Area.

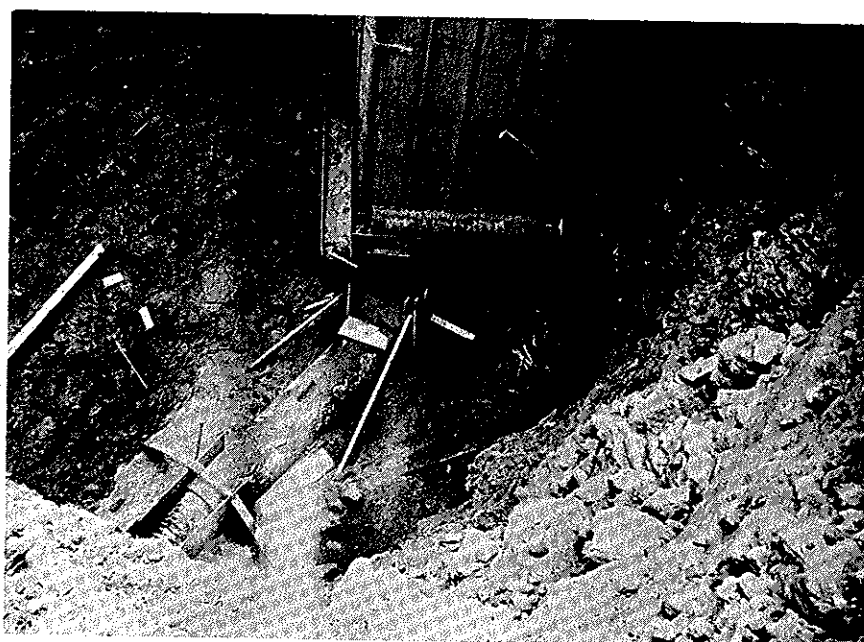
Figure 15. Ten-Inch Effluent Pipe From Dickman Lake Cutoff Drains.

A trench was dug between the lake dam and the south cutoff trench across the interstate. A 14-inch hole was augered under the dam to the point of intersection of the lake drains. A 10-inch pipe was pushed through the hole (Figure 15) and connected to the bottom pipe of the cutoff trenches. Sand backfill was placed in the trench and the piles on the south side were removed.

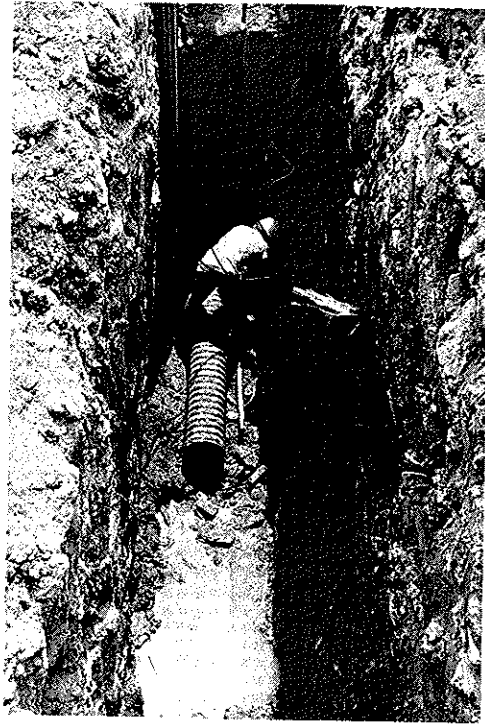
Figure 18. Trench Drain Pipe Under 4-Foot by 4-Foot Box Culvert,

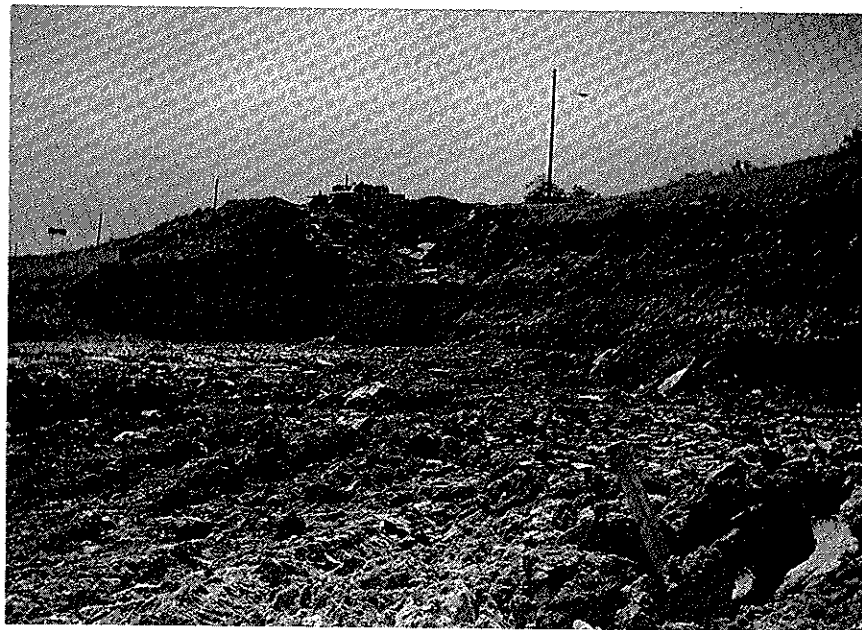
Figure 22. South Bench Construction.

Reconstruction plans called for the removal of the top 30 feet of the fill and the construction of a 4:1 slope starting at an elevation of 30 feet below the pavement and extending downward towards Highland Avenue. During the construction of the cutoff trench parallel to the toe of the embankment, additional movement of the fill could not be restrained. Cracks developed that ranged from a fraction of an inch to 18 inches wide and as much as 54 inches deep. The north and south ends of the fill became riddled with cracks from top to bottom; however, the center portion remained stable. A change order was issued to provide for additional drainage at the north and south ends of the original slide area. In order to place these pipe, benches were excavated -- the south bench extended from Station 486+00 to 489+50 and averaged approximately 75 feet in width (Figure 22) and the north bench extended from Station 490+50 to Station 493+00 and also averaged about 75 feet in width (Figure 23).

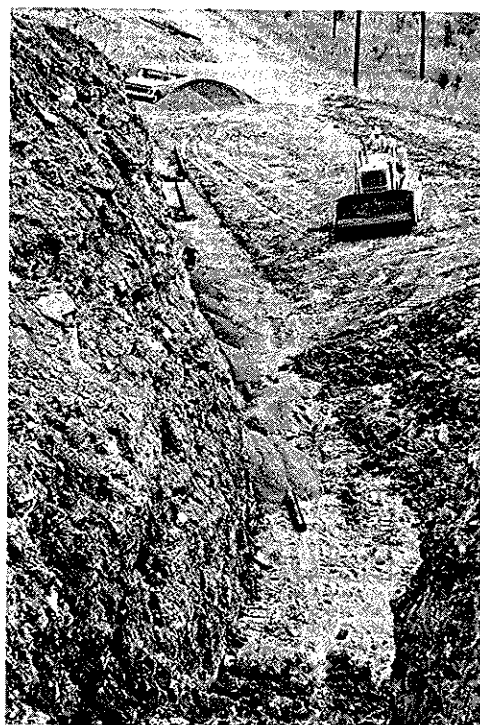
Figure 23. North Bench Construction and North Bench Drain with Sand Backfill.

The general cross section of both benches was such that water would drain from the top edge of the 4:1 slope towards the road (Figure 23). This necessitated the installation of a 10-inch perforated pipe, with perforations down, at the intersection of the vertical face and the bench floor. Sand backfill was placed in sufficient quantity to cover the pipe. An elbow was installed at the low end and a 10-inch perforated carry-off pipe, with perforations up, was connected to the elbow. The carry-off pipe was installed so that five feet extended beyond the surface of the 4:1 slope. The free ends were positioned near the raised manhole (Figure 25).

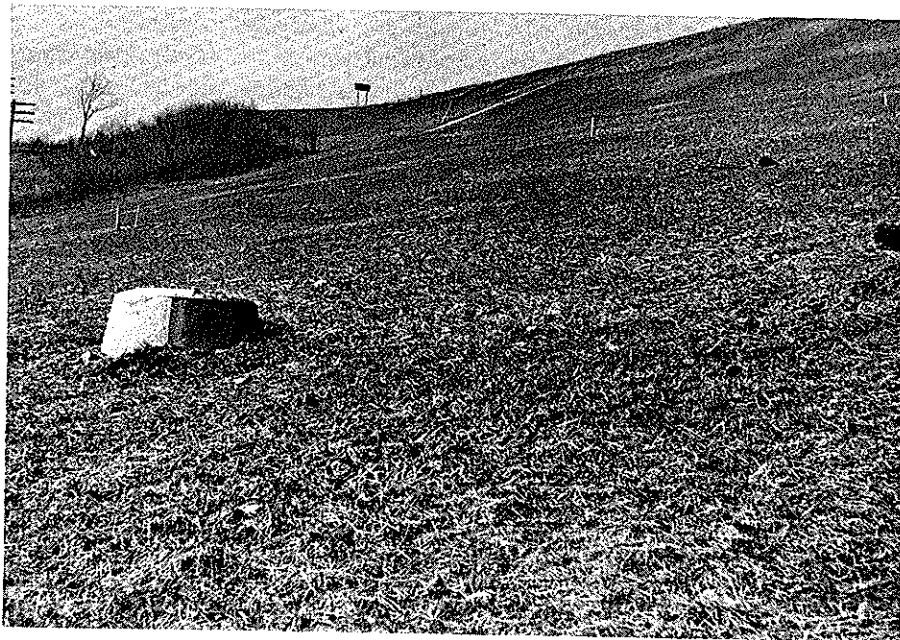
Figure 25. North and South Bench Drains and Raised Manhole.

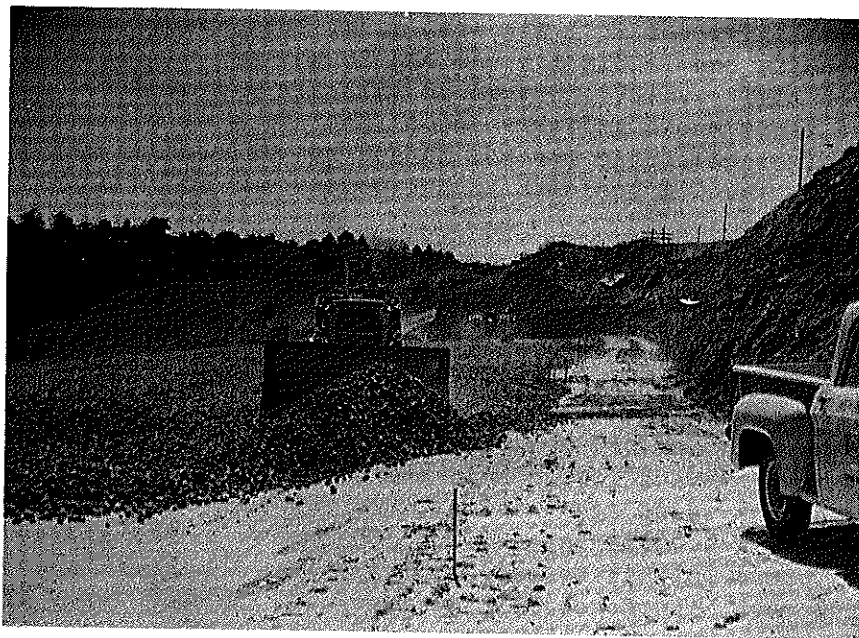
Figure 26. Lightweight Slag Fill.

The embankment area was brought on a 4:1 slope to a grade line 30 feet below the pavement. At this point the slope was changed to 2:1, and a lightweight slag was used as fill (see Figure 26). The slag fill extended under the outside 12-foot driving lane and 12 feet to the right of the curb line. A two-foot thick clay blanket was placed over the horizontal slag surface, and an 18-inch thick lift was placed over the side slope of the slag. All newly constructed slopes were seeded.
